A STUDY OF HIGH POWER ARGON LASER OPTICS

FINAL REPORT

Contract NAS 12-548

RAYTHEON COMPANY
Research Division
Waltham, Massachusetts

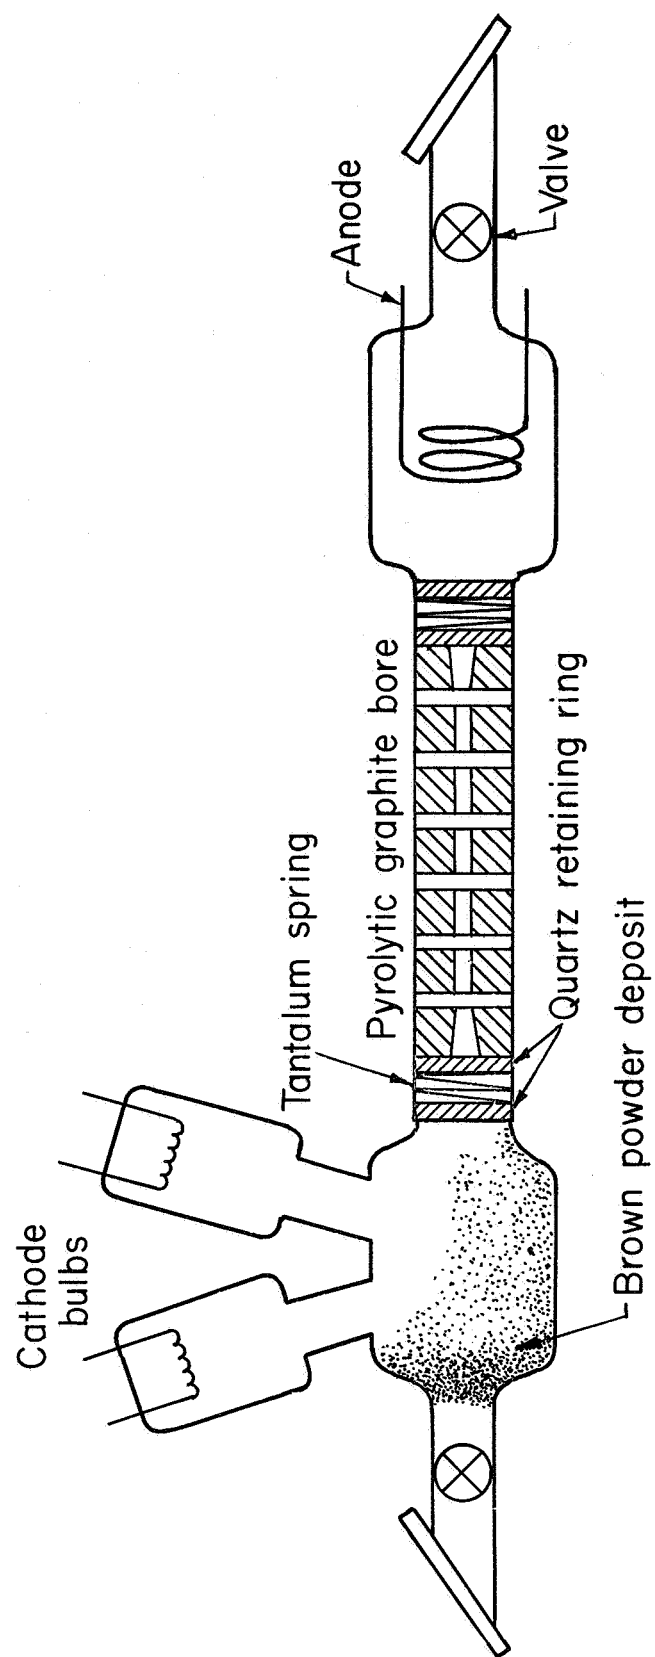
FIGURE 17

A brownish deposit accumulated on the walls of the bulbous section at the cathode end of the pyrolytic graphite bore laser as indicated in Fig. 17. When a modification of the structure was made, this material was removed and proved to be powdery in composition. This powder deposit had slowly accumulated during the previous eight months of laser operation. Samples of this powder were analyzed with the electron beam microprobe. The analysis revealed that some particles showed only the presence of silicon, while others contained no silicon but instead many other metallic elements. Listed in order of decreasing amounts, these elements were: Ba, Fe, Mn,

SCHEMATIC DIAGRAM OF PYROLYTIC GRAPHITE BORE LASER

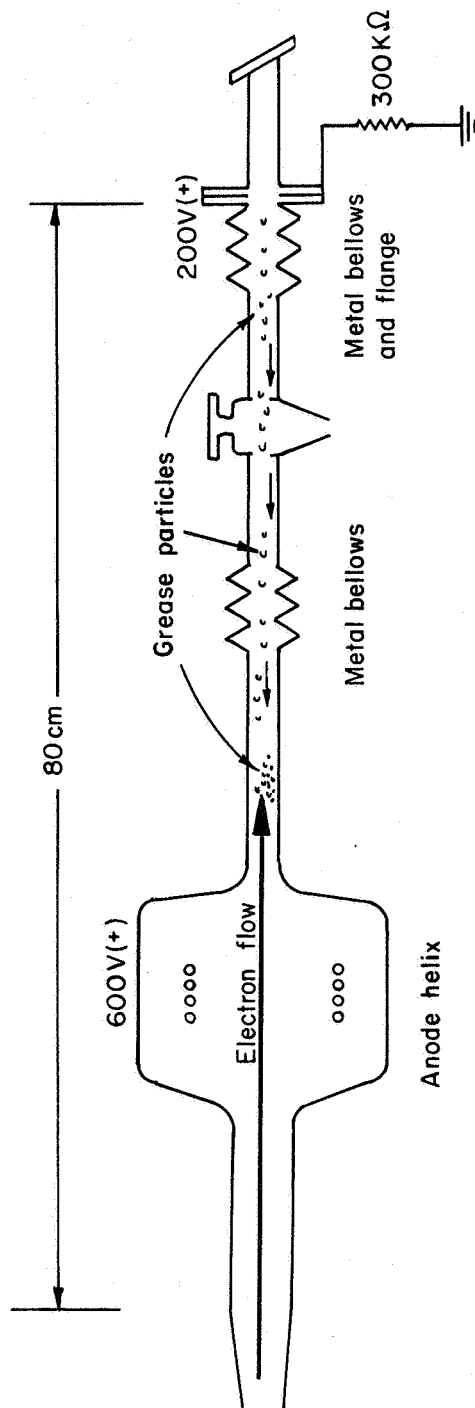
FIGURE 20

If a potential gradient between the anode and the end bellows was artificially introduced by establishing a current-limited ground path, as indicated in Fig. 20, the resulting field was sufficient to transport negatively charged particles toward the anode. Some particles, believed to be grease particles emanating from the stopcock, scattered the lasing radiation and thus acted as tracers of this charge transport. These particles were constrained to move down the center line of the envelope by the repulsion of the static negative charge on the walls. That they were negatively charged was confirmed by magnetic deflection of the stream of particles. Near the anode bulb a cusp-shaped distribution of suspended particles was observed which presumably marked the juncture with the electron stream accelerated through the anode. This cusp-shaped distribution of particles moved further away from the anode with increasing discharge current. When the ground path was removed from the bellows, the larger particles immediately dropped to the bottom of the tube and the smaller particles rapidly moved away from the anode, decelerated and gradually diffused out of the beam.

PARTICLE FLOW OBSERVED WITH VOLTAGE GRADIENT ESTABLISHED
BETWEEN END FLANGE AND ANODE

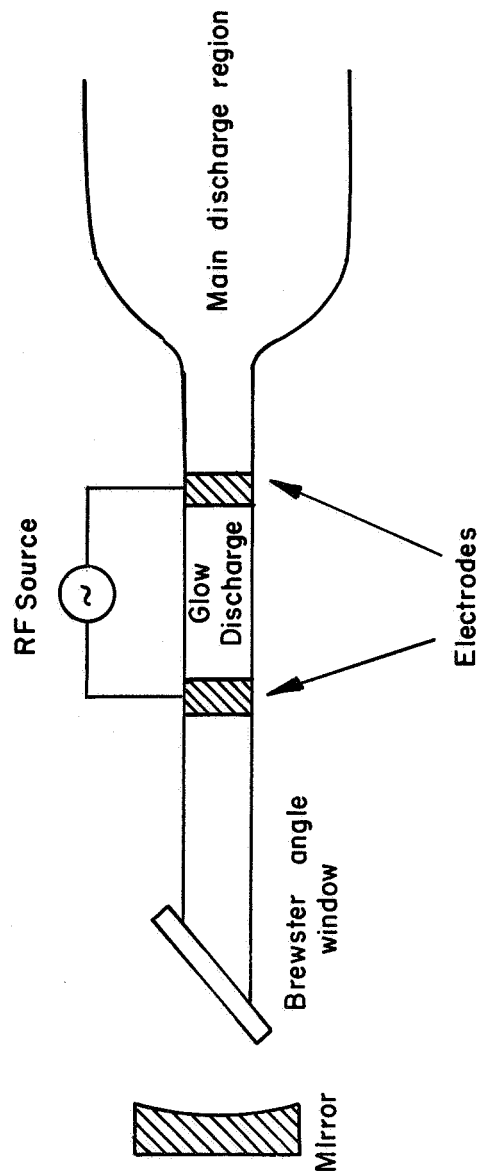
FIGURE 23

RF DISCHARGE USED FOR THE RESTORATION OF TERMINAL OPTICS

This result was followed up using a more refined method establishing the rf discharge, in which the rf was applied between an external electrode around the tube, located a few centimeters from the window, and the flange while the laser was operating as is shown in Fig. 23. A dramatic cleanup of the window (Fig. 24) was observed within the first minute after initiating the rf discharge. Further tests with the rf technique, which had no adverse effects on the output during the application time, indicated that re-establishment of the window film was inhibited particularly with high discharge current and high optical power operation.

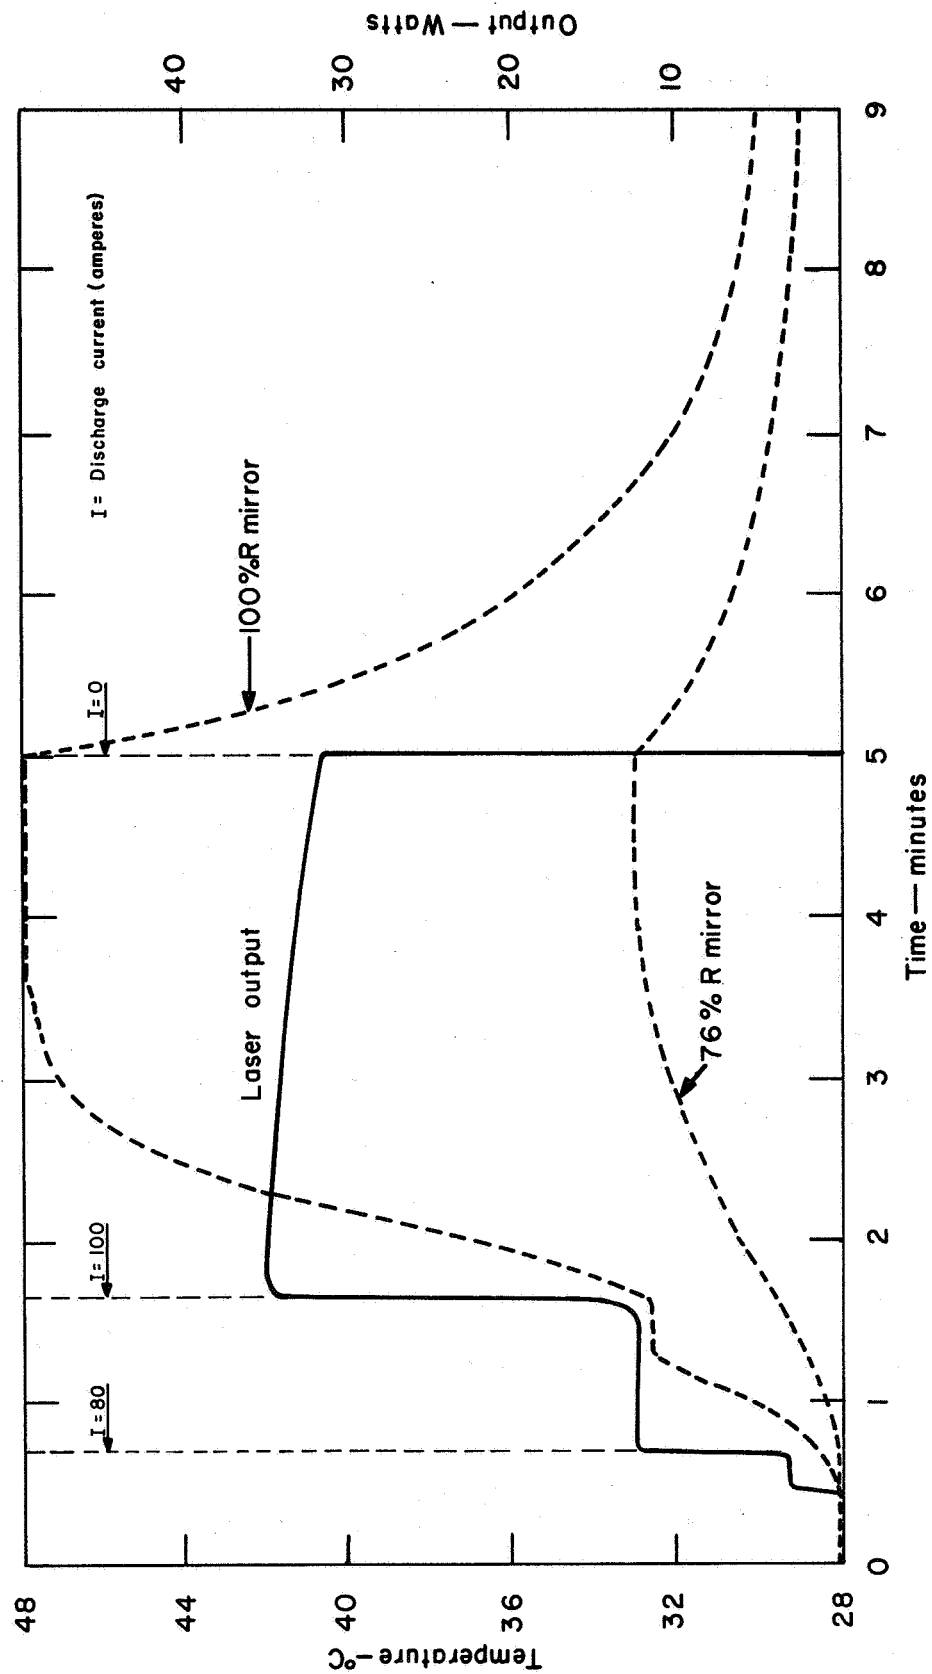
FIGURE 25

A study was made of the effects of thermal distortion of the mirrors on the performance of the laser. The use of various output couplings to control the loading on the mirrors led to the observation of significant thermal effects. Output coupling values of 34 and 24 percent were tested using 10-meter radius substrates which were only 0.75 in. dia. by 0.25 in. thick. This configuration was much more sensitive to heating than the larger, shorter radius standard geometry. The results of the experiments with the 24 percent output coupling are given in Fig. 25. Rather large temperature rises were observed on both mirrors. With severe heating the laser output power fell about 10 percent.

BULK TEMPERATURE OF END MIRRORS MONITORED DURING LASER OPERATION.
